**BRIDGESTONE/FIRESTONE, INC**

Subject VALENCIA ADJUSTED TIRE MINI SURVEY- OCTOBER 25-28

# VENEZUELA TIRE SURVEY WILDERNESS AT TIRES ADJUSTED BY SIZE

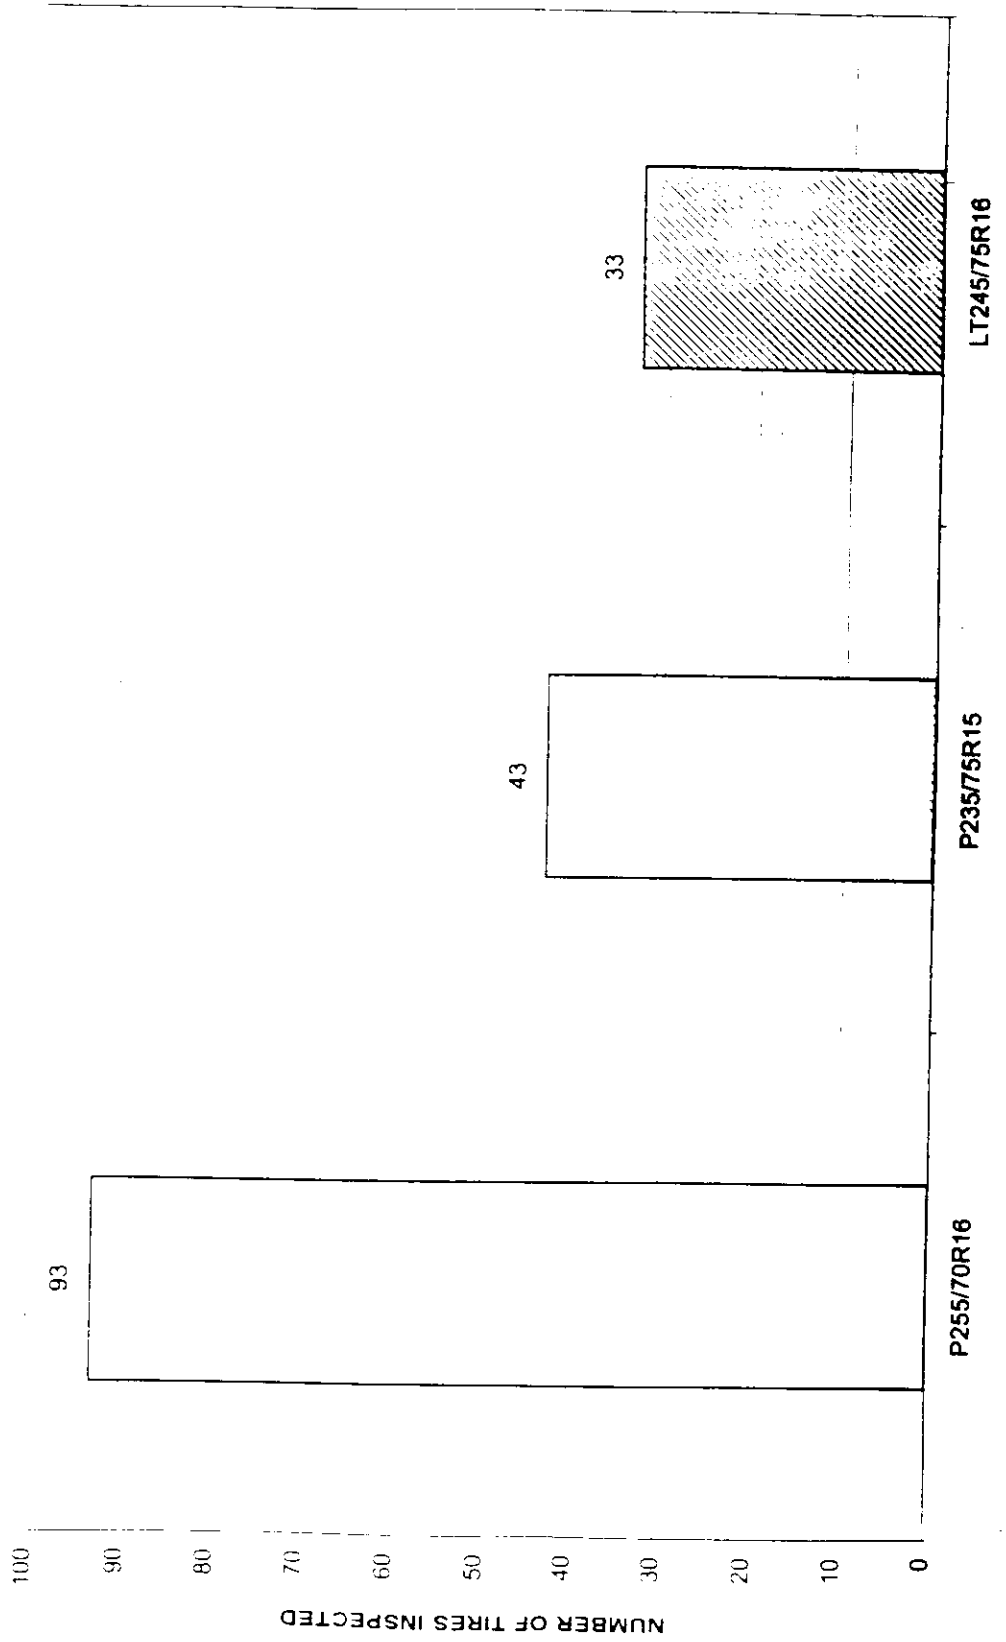
Based on the sample we inspected, the LT 245/75R16 adjusts at a higher rate for BES and BLB than the P265/70R16 and the P235/75R16.

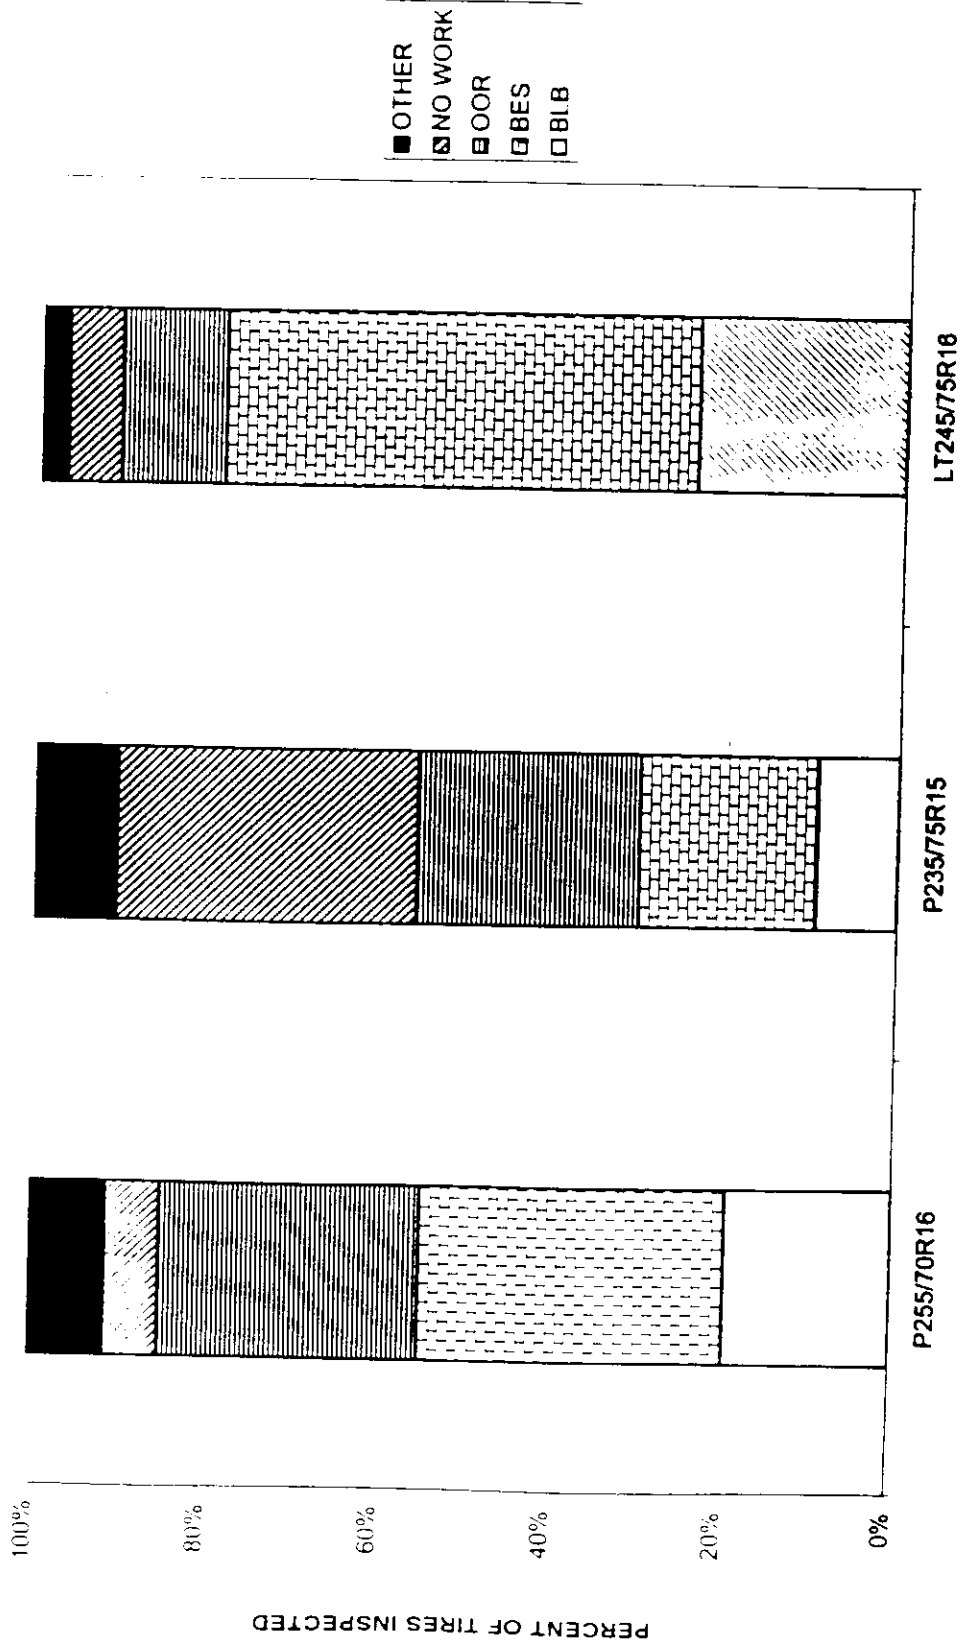
## PERCENT OF ADJUSTMENTS BY ADJUSTMENT REASON

On the attached charts, there is an abbreviation for the adjustment condition, "no workmanship and materials found". On the Percent of Adjustments chart it says "no work" and on the Adjustment Vs repaired tires chart it says, "work".
