# TransCanada's Keystone XL Southern Segment:

## Construction Problems Raise Questions About the Integrity of the Pipeline

November 2013

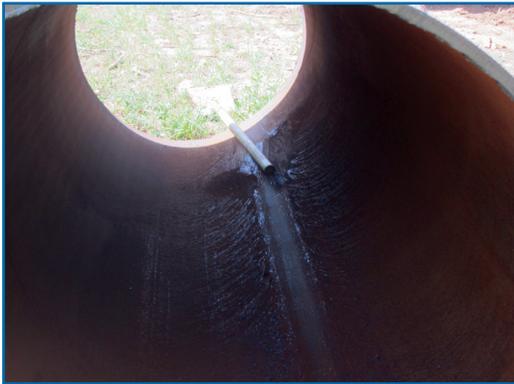
*The two shots are of the exterior and interior of a massive dent from the inside of a pipe section near Jacksonville, Texas.*

Dents were among the anomalies identified in new pipe excavated along the pipeline route. The code currently allows only for nominal mechanical deformation.<sup>45</sup> Some dents that were observed were as deep as that of a brick. Dents most often occur when pipe is placed in a trench where rocks or debris are present.<sup>46</sup> The code of construction requires pipe to be laid flat on the bottom of the trench and firmly supported. Once the trench is ready to be backfilled with soil to close the ditch, any remaining debris underlying the pipe can dent the pipe due to the downward weight and pressure of the compacted soil and backfilling equipment.<sup>47</sup>

Dents can provide major areas of stress concentration on a pipeline, since cracks will often develop over time where the creases of dents occur, fostering the probability of a leak or rupture where those stress points are located on the pipe, especially if dents occur on welds.<sup>48</sup> It is a qualified inspector's responsibility to ensure that the construction contractor does not lay or cover pipe in a ditch until the ditch can provide smooth, firm underlying support for the pipeline, as mandated by the quality assurance requirements of the construction code.<sup>49</sup> Fuel Fix photos published in late October, along with photos from the Houston Chronicle, indicate that the ditching inspector did not ensure that rocks were removed from the trench before lowering the pipe into the ditch.<sup>50</sup> Aerial pictures of an active excavation site showed that rocks were removed from under a portion of the pipeline that was excavated.

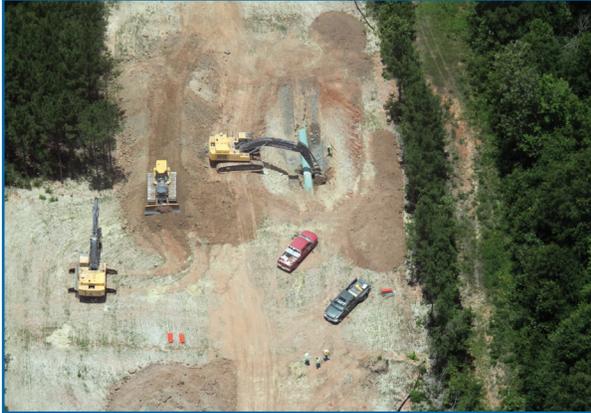
*In filling the trench on this construction site near Lufkin, the trackhoe's bucket is pulling soil near the pipe, affording the possibility for the bucket to hit the line.*

The code of construction has identified improper backfilling as a source of serious pipe damage. Proper filling and compaction of the soil protects the pipeline. Ground disturbance loosens the soil, which must then be recompacted below and around the pipe to re-establish the pipeline's load-bearing capacity.<sup>57</sup>

Improper filling and compaction coupled with subsequent agriculture work, can strain welded areas and can cause pipe damage, especially when there is no internal pressure in the pipe during construction activities, which exacerbates the problem.<sup>58</sup>
