**Re: Need for Renotification to Patients With the Bjork-Shiley
Convexo-Concave Valve in Light of New Findings of Extremely
High Failure Rates**

Single-leg strut fractures in explanted Björk-Shiley valves

Re: Request for Assistance From the U.S. Food & Drug Administration
Regarding Matter of Major Health Concern Pertaining to Björk Shiley 60°
and 70° Convexo/Concave Heart Valves Implanted in Dutch Citizens.

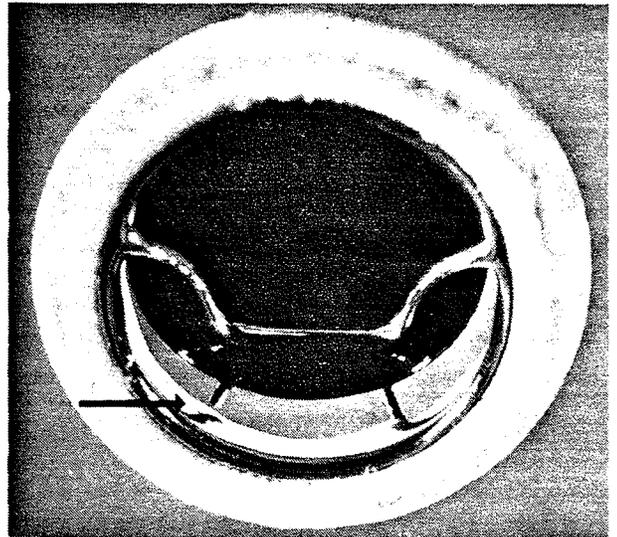
Figure 1: Mitral BS cc valve (29 MBRC; 10032) with occluder in situ

Note displacement due to SLF of minor strut (arrow).³

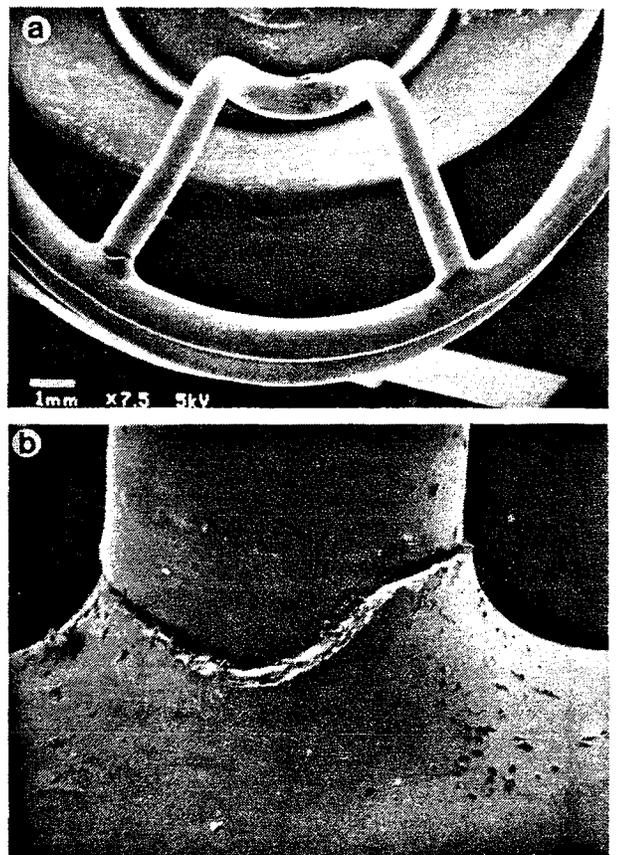
Figure 2: SEM of valve number 14 in this series (27 ABCB; 10168)

One leg of minor outlet strut is fractured through wall from flange. Note bend in fractured strut leg and its asymmetrical position in comparison with intact leg of strut. Reduced by a third from a = $\times 7.5$, b = $\times 62$.
