Dynamic JRS Rollover Occupant Protection Tests Of Five Contemporary Sedans using Hybrid III Dummies

September 9, 2008

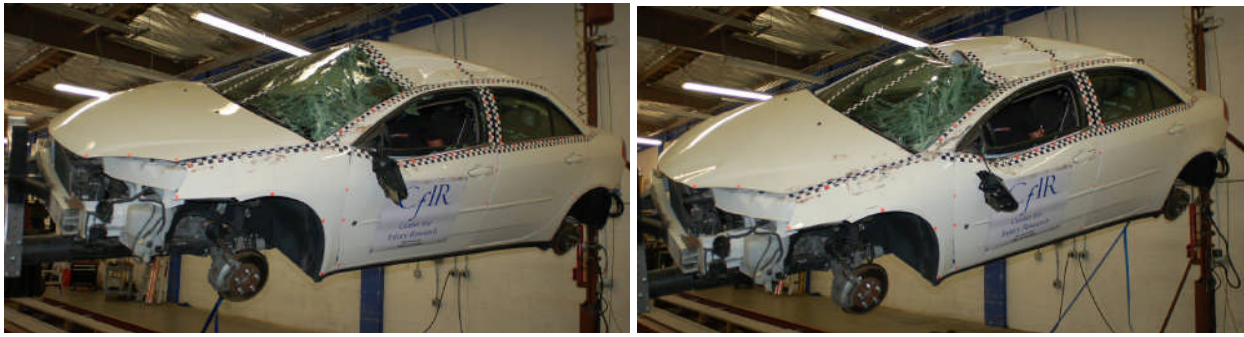
Pontiac G6. Figure 1 shows the Pontiac G6 after the first and second rolls. Note the extensive windshield header and roof panel buckling and intrusion of the roof panel over the driver position.

The roof of the G6 suffered major structural failure in the first roll, and the second roll increased the damage only marginally. The windshield header buckled in numerous places indicating that it is completely inadequate to ensure structural integrity in a rollover. The driver's side window broke in the first roll, but the remaining side windows survived both rolls.

Figure 1. Pontiac G6 after first (left) and second roll JRS tests.

The Pontiac's curb weight is 3,422 pounds and its test weight was 3,179 pounds. It has an FMVSS 216 SWR of 2.3, the lowest among the tested vehicles. It registered a maximum road impact load with the first side of the roof of 10,605 pounds and of 19,062 pounds on the second side on the first roll test. The higher road impact load in the second test occurs because of the impact between the lower body of the vehicle and the road. The total residual roof intrusion at the A pillar was 4.9 inches after the first roll and 7.0 inches (an additional 2.1 inches) after the second.

This vehicle would not comply with the weak, proposed upgrade of FMVSS 216. The roof intrusion rate on the first roll would have inflicted serious injury to a driver whose head is located in the path of maximum intrusion. The intrusion rate in the second roll was sufficient to inflict injury to a driver in virtually any position near the roof rail. This vehicle would have to be considered defective for its excessive roof intrusion and intrusion rates.

The maximum neck loads and neck injury criterion in these two tests were moderate because the safety belts permitted sufficient excursion of the dummy that friction between the head and interior headliner kept the dummy away from the roof rail area. This is partly a function of the very stiff neck of the dummy that prevented it from bending to permit the occupant to move into the path of the roof's greatest intrusion and partly a function of the poor belt restraint. The measurements of roof intrusion provided confirmation of the high injury potential of roof intrusion in this vehicle.

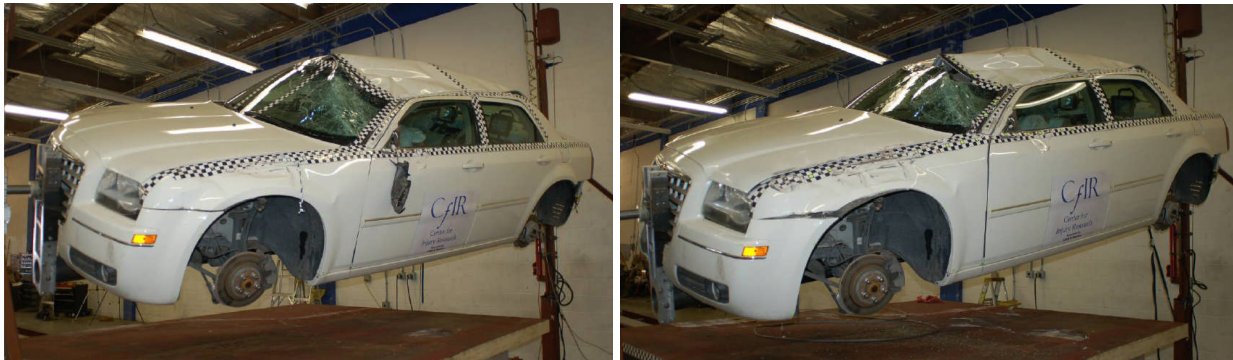
Chrysler 300. Figure 2 shows the Chrysler 300 after the first and second rolls. It registered a maximum road impact load with the first side of the roof of 11,604 pounds and of 24,001 pounds on the second side on the first roll test. The latter was due to the impact of the lower side of the vehicle with the road segment. The FMVSS 216 SWR was 2.5. Note the extensive windshield header buckling and intrusion of the roof panel over the driver position.

The Chrysler's curb weight is 3,726 pounds and its test weight was 3,941 pounds. The total residual roof intrusion at the A pillar was 5.6 inches after the first roll and 7.4 inches after the second. The intrusion at the roof buckle was even greater. According to NHTSA, this would significantly increase the probability of a head, face or neck injury in a rollover.

Figure 2. The 2006 Chrysler 300 after the first JRS roll test (left) and second roll.

The Chrysler 300 barely met the roof crush resistance value proposed by NHTSA in 2005, and did so in its two-sided test. However, the roof showed serious performance deficiencies in our dynamic testing. We would rate the rollover occupant protection capability of this vehicle as poor based on the amount and speed of roof intrusion, and on the high peak neck load and neck injury criterion in the first roll test.

Despite the severity of roof crush, the side windows survived both rolls, apparently because the side window frames retained their shape and did not twist excessively. The left side window frames were bent toward the center of the vehicle but were not distorted. The rear roof panel suffered significant weld failures as seen in Figure 11.

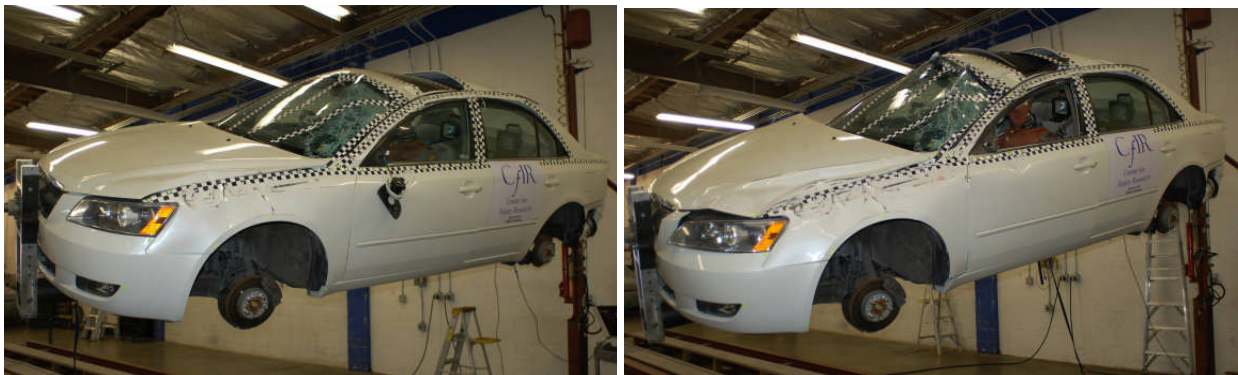
Hyundai Sonata. Figure 3 shows the 2006 Hyundai Sonata after the first and second rolls. It registered a maximum road impact load with the first side of the roof of 12,955 pounds and of 17,711 pounds on the second side on the first roll test. The FMVSS 216 SWR was 3.2. The damage to the initially leading side of the roof increased substantially in the second roll, which is somewhat unusual in both JRS tests, and indicates that the damage to the second side in the first test substantially weakened the roof overall.

The Sonata's curb weight is 3,266 pounds and its test weight was 3,501 pounds. It registered a maximum road impact load with the second side of the roof of 17,711 pounds during the first roll and 31,380 during the second. The side windows survived the first roll, but the driver's window broke in the second roll.

Figure 3. The 2006 Hyundai Sonata after the first JRS roll test (left) and second roll.

The residual roof intrusion at the A pillar was 2.6 inches after the first roll and could not be measured after the second because of interference between the dummy and the string potentiometer. Although the intrusion over the driver position was reasonable, the

tenting of the windshield header and damage to the roof on the passenger side indicate problems with the overall structural integrity of the roof of this vehicle.

The Sonata would meet NHTSA's proposed roof crush resistance criteria with a SWR greater than 2.5 in the FMVSS 216 test, but its performance showed serious structural weakness in the JRS test and a significant probability of injury to the driver in these rollover tests. We would rate the rollover occupant protection performance of the Hyundai Sonata as marginal to poor based on the peak neck load and neck injury criterion in the first roll test, the peak roof intrusion speed in the second roll, the excessive intrusion of the passenger side roof, and the driver's side window failure.

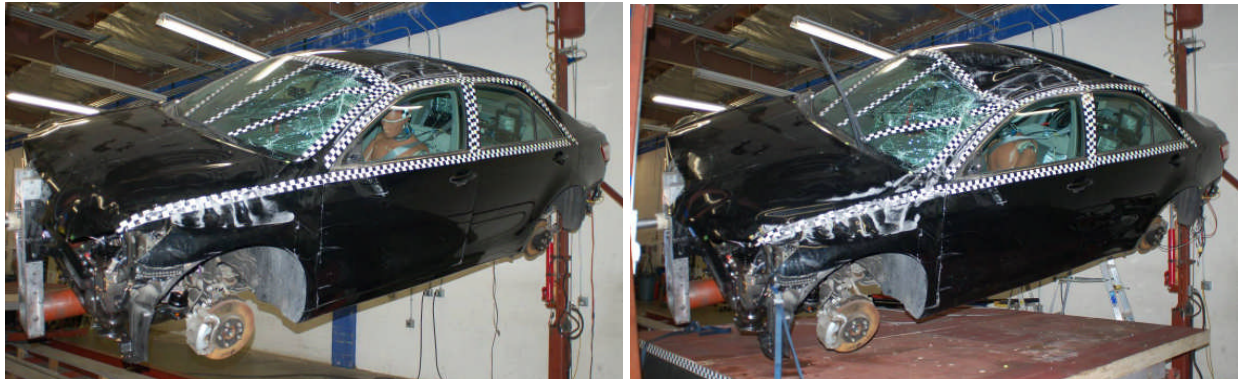
Toyota Camry. Figure 4 shows the 2007 Toyota Camry after the first and second roll tests on the JRS.⁶ The Toyota's curb weight is 3,260 pounds and its test weight was 3,176 pounds. Its FMVSS 216 SWR is 4.3. It registered a maximum road impact load with the first side of the roof of 14,188 pounds and of 19,242 pounds on the second side on the first roll test. The vehicle looked fairly good after the first roll test (although there was incipient damage at the left end of the windshield header), but developed significant buckles in the windshield header in the second roll. Toyota uses high strength steel in the pillars and roof rails at the side of the roof of its Camry and Corolla models, but they have weak windshield headers as demonstrated in this test.

Figure 4. The 2007 Toyota Camry after the first roll JRS test (left) and the second.

Viewing the videotape and the traces from the string potentiometers on the fixture support towers showed that the impact with the near side of the roof virtually halted the fall of the vehicle's center of gravity (with a much higher road impact load than the vehicles with weaker roofs) so that the far side roof impact was less severe than with the weaker roofed vehicles. This indicates that one important benefit of a strong roof is its ability to sustain high loading in the first side impact so that the far side impact is less severe.

Unfortunately, the first roll test sufficiently weakened the roof structure that on the second roll, this effect was much weaker. On the second roll, the Camry registered a maximum road impact load with the first side of the roof of only 7,506 pounds but of 25,088 pounds on the second side on the second roll test because the roof crush permitted substantial contact between the lower body of the vehicle and the road segment. High strength steel is used in the side structure of the roof, but not the windshield header. It protected the side windows from breakage in both rolls on the JRS, a major plus in reducing the potential for occupant ejection.

It registered a maximum road impact load with the second side of the roof of 19,242 pounds on the first roll test and 25,038 pounds on the second. The residual roof intrusion at the A pillar was 1.6 inches after the first roll and 4.7 inches after the second. The intrusion at the roof buckle was somewhat greater. This vehicle had only marginal headroom after the second roll test according to NHTSA's headroom criterion.

The Toyota Camry substantially exceeded NHTSA's proposed roof crush resistance criterion of a SWR of 2.5. However, the performance of its windshield header shows that performing well in the FMVSS 216 test does not guarantee good dynamic rollover performance. Attachment B is a paper by Nash that shows that this weakness affects the performance of various Toyota vehicles in actual rollovers captured by the National Accident Sampling System (NASS).

We would rate the rollover occupant protection of the Camry as fair. The good side structure of the roof is compromised by the weak windshield header that permitted high roof intrusion speed in the second roll test. The real world performance of the Camry gives little confidence that the Camry's rollover performance is much better than average. These test results show why the conditions of the current FMVSS 216 test, even if repeated on the second side, are not adequate to ensure good roof crush resistance.

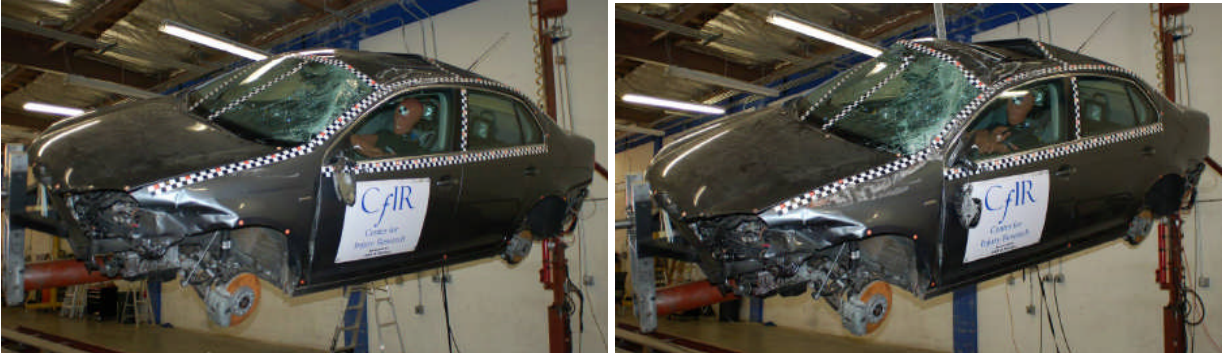
Volkswagen Jetta. Figure 5 shows the Volkswagen Jetta after the first and second rolls. Despite its very high FMVSS 216 SWR, the windshield header suffered significant damage in the second test.

The Jetta's curb weight was 3,272 pounds and its test weight was 3,316 pounds. Its FMVSS 216 SWR is 5.1. It registered a maximum road impact load with the first side of the roof of 16,501 pounds and of 17,362 pounds on the second side on the first roll test. This vehicle shows the same effect seen in the first Camry roll: the strength of the roof in the near side roof impact moderated the force in the second side impact. As with the Camry, the damage from the first roll reduced the near side strength so that the road impact loads in the second roll were 10,312 and 20,798 pounds, respectively. The windshield header buckled significantly in the second roll, but moved outward so that there was only modest roof intrusion in the second roll.

Figure 5. Volkswagen Jetta after first (left) and second roll JRS tests.

At a SWR of 5.1, the Jetta had the highest SWR in FMVSS 216 testing seen in any production vehicle. Nevertheless, the dummy had moderately high neck loads in the VW tests because the dummy's head was in the direct path of maximum roof intrusion, and the roof showed significant buckling in the tests. The duration of the high loads was relatively short suggesting that a human neck would not have been seriously injured under the same conditions. We would rate the Jetta's rollover occupant protection performance as fair to good.

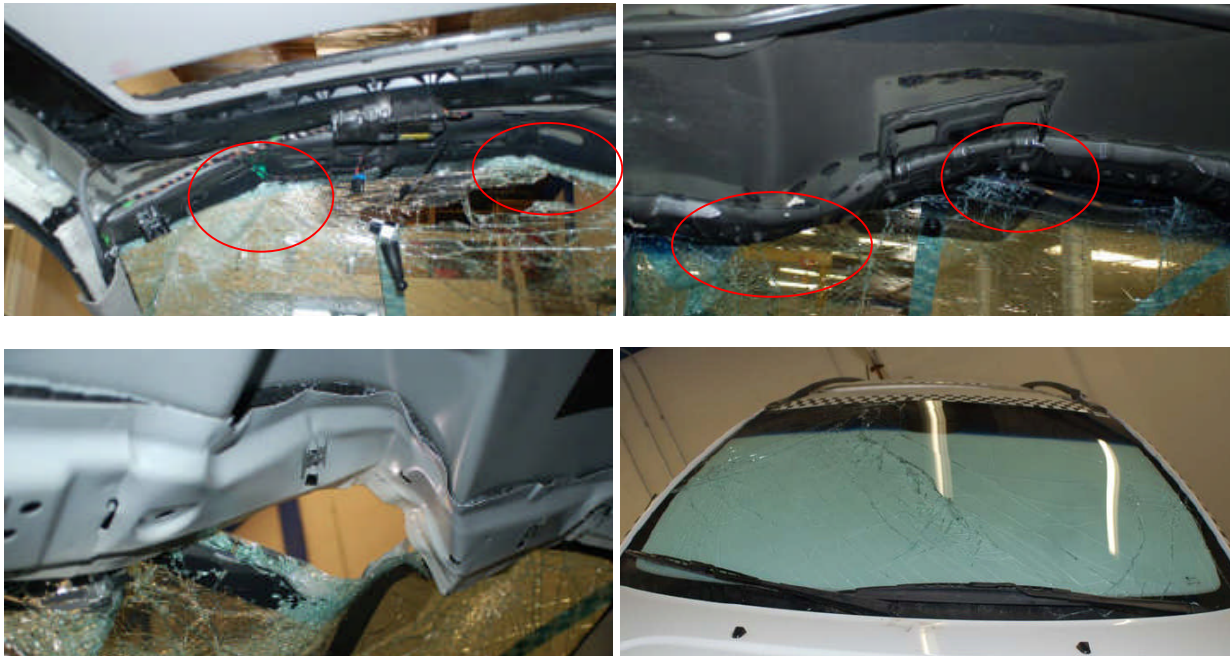
It is useful to compare the performance of the two vehicles with the highest FMVSS 216 SWR with the Volvo XC90 (Figure 6) which has a lower SWR (around 4.6). After two tests at 5° pitch, the 2004 Volvo XC90 showed insignificant residual structural failures. Both the Toyota Camry and the Volkswagen Jetta showed modest structural damage in the first test and more substantial structural failures in the second roll. These results show that although Toyota and Volkswagen have successfully reduced the potential for ejection in these two vehicles, their manufacturers should address the design or materials of the windshield header to achieve a high level of occupant protection.

Figure 6. Interior views of the Jetta (above left) and Camry (above right) show buckled windshield headers after the second roll test. The G6 (below left) windshield header performed particularly poorly. The Volvo XC90, after two roll tests at 5° pitch on the JRS (below right), shows no structural failures.

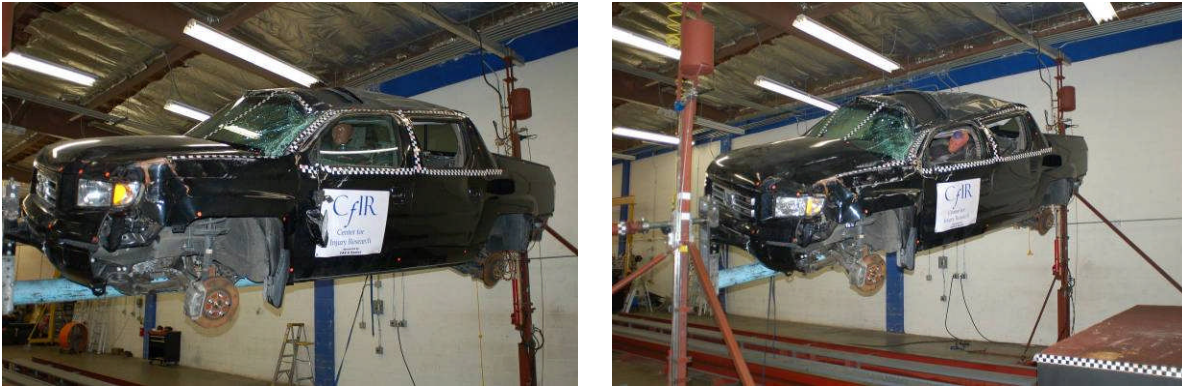
Figure B1 shows the Honda Ridgeline after the first and second rolls. Note the extensive windshield header and roof panel buckling and intrusion of the roof panel over the driver position and the catastrophic damage after roll 2.

Figure B1. The Honda Ridgeline after first (left) and second roll JRS tests.

The Ridgeline's curb weight is 4,453 pounds and its test weight was 4,467 pounds. It has an FMVSS 216 SWR of 2.4. It registered a maximum road impact load with the first side of the roof of 13,544 pounds and of 20,385 pounds on the second side on the first roll test. The total residual roof intrusion at the A pillar was 5.0 inches after the first roll and 10.9 inches after the second.

The roof of the Ridgeline suffered substantial structural distortion in the first roll. The structure failed catastrophically in the second roll such that the top of the A pillar intruded below the beltline of the vehicle. The dummy's head was forced outside the

envelope of the Ridgeline because of the extensive distortion of the roof, and it is clear that had a human been subjected to these conditions, the result would have been a fatal injury. It is ironic that this situation would have been coded a partial ejection by NHTSA although the dummy did not move significantly from its normally seated position. Rather, the envelope of the vehicle was so distorted that it no longer contained or protected the head of a normally seated occupant.

This vehicle would nearly comply with the weak, proposed upgrade of FMVSS 216, but its rollover performance is, in our opinion a serious safety defect that should result in a safety defect recall. The roof intrusion rate on the first roll would have inflicted serious injury to a driver whose head is located in the path of maximum intrusion. The forces on the dummy in the second roll would have had a high potential to have fatally injured an occupant subjected to the same forces under this defective roof.

The results of this test should be compared with the results of the Chrysler 300 test discussed above. Both vehicles had similar FMVSS 216 performance, and the 300 performed poorly, but the Ridgeline had a catastrophic roof failure in its second roll that was far more hazardous than the roof intrusion of the Chrysler 300. Furthermore, none of the Chrysler's side windows broke in its JRS tests while one of the Ridgelines left side windows broke in the first test and another broke in the second roll opening major avenues for occupant ejection.

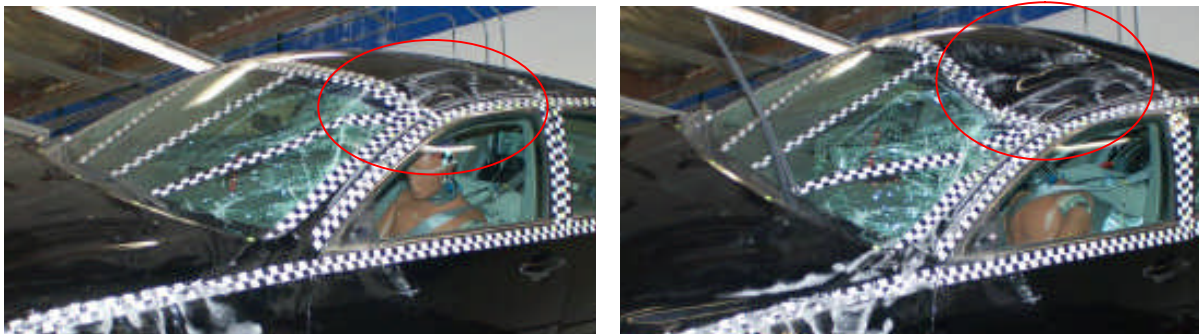
The Center for Injury Research has tested two Toyota passenger cars, the Corolla and the Camry, on the dynamic Jordan Rollover System (JRS). In those tests, a weakness in the structure of the tested vehicles became obvious: the windshield header is weak and likely to buckle under dynamic loading (see Figure 1).

Figure 1. Photographs of a 2007 Toyota Camry roof after one roll and after two rolls in a JRS test showing the buckling of the windshield header in this vehicle. The Toyota Corolla showed similar buckling in a JRS test.

Except for a couple of cases, we found that Toyota roofs generally looked good after a rollover except that in many cases the windshield header buckled. This behavior mirrors the results of the JRS tests.
