Industry Concealment of Tests Undermined Development of Meaningful Rollover Crash Roof Crush Resistance Standard in 1971

Auto Industry Conceals Truth, as Now Revealed by Internal Company Documents

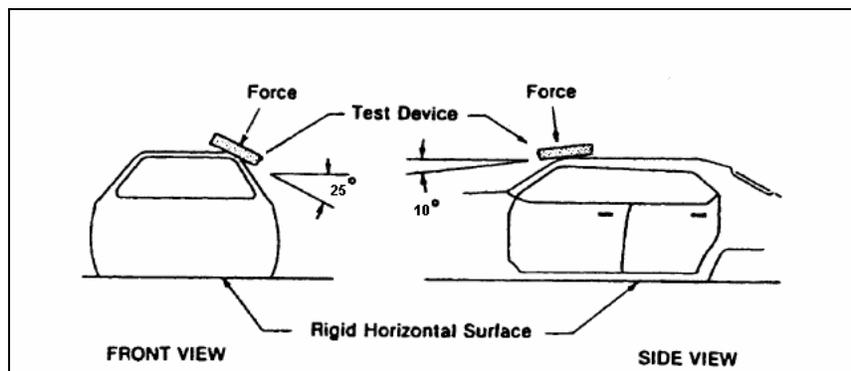
The agency’s initial proposal was a test of both front corners of a passenger vehicle roof. Both corners would be tested by lowering a 12-inch square platen, angled forward 10 degrees horizontally and 25 degrees laterally, successively onto each front corner, increasing the force until it equaled one-and-one-half the weight of the vehicle, or 5,000 lbs., whichever was less. To pass the test, the roof could not have more than 5 inches of intrusion into the passenger compartment.

Graphic for illustration purposes only, not from litigation papers.

In its comments, the auto industry sought to weaken the standard in several key ways. The first was to change the orientation and dramatically increase the size of the platen. GM argued, on page 3, that NHTSA’s proposal for a 12-inch by 12-inch platen was too small of an area of the roof to be appropriate for the test. GM urged NHTSA to substantially increase the size of the testing platen to at least 30 inches by 72 inches, to provide “a more realistic loading condition for evaluating roof strength.” On the eighth page of its comments, the AMA also recommended the use of a large platen. Moreover, both GM and the AMA suggested — on the 6th and 8th pages, respectively — that the forward horizontal orientation of the platen be reduced from ten degrees to five.
